# INVESTIGATION REPORT

## EXPLOSION AND FIRE

### FIRST CHEMICAL CORP.

REPORT NO. 2003-01-I-MS

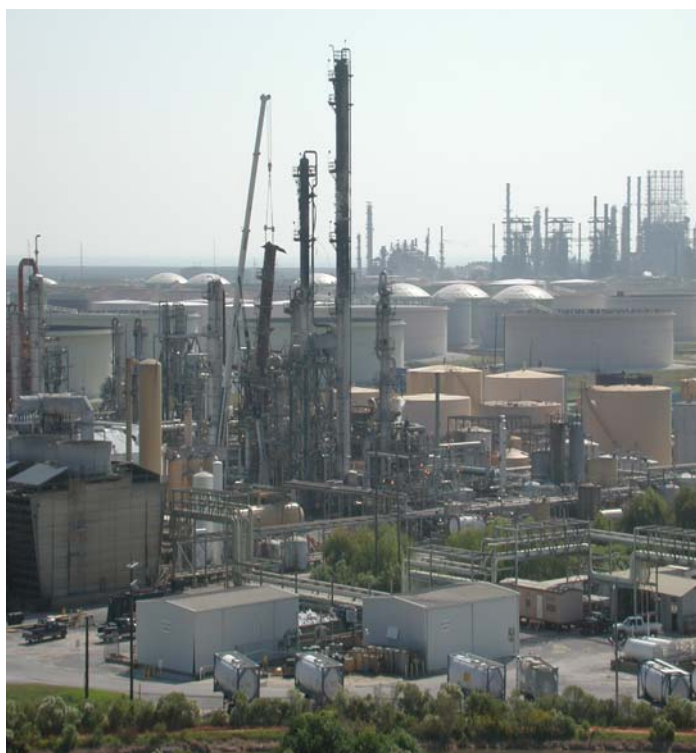
Figure 1. Facility overview. (Note: The crane is attached to a column damaged in the explosion.)

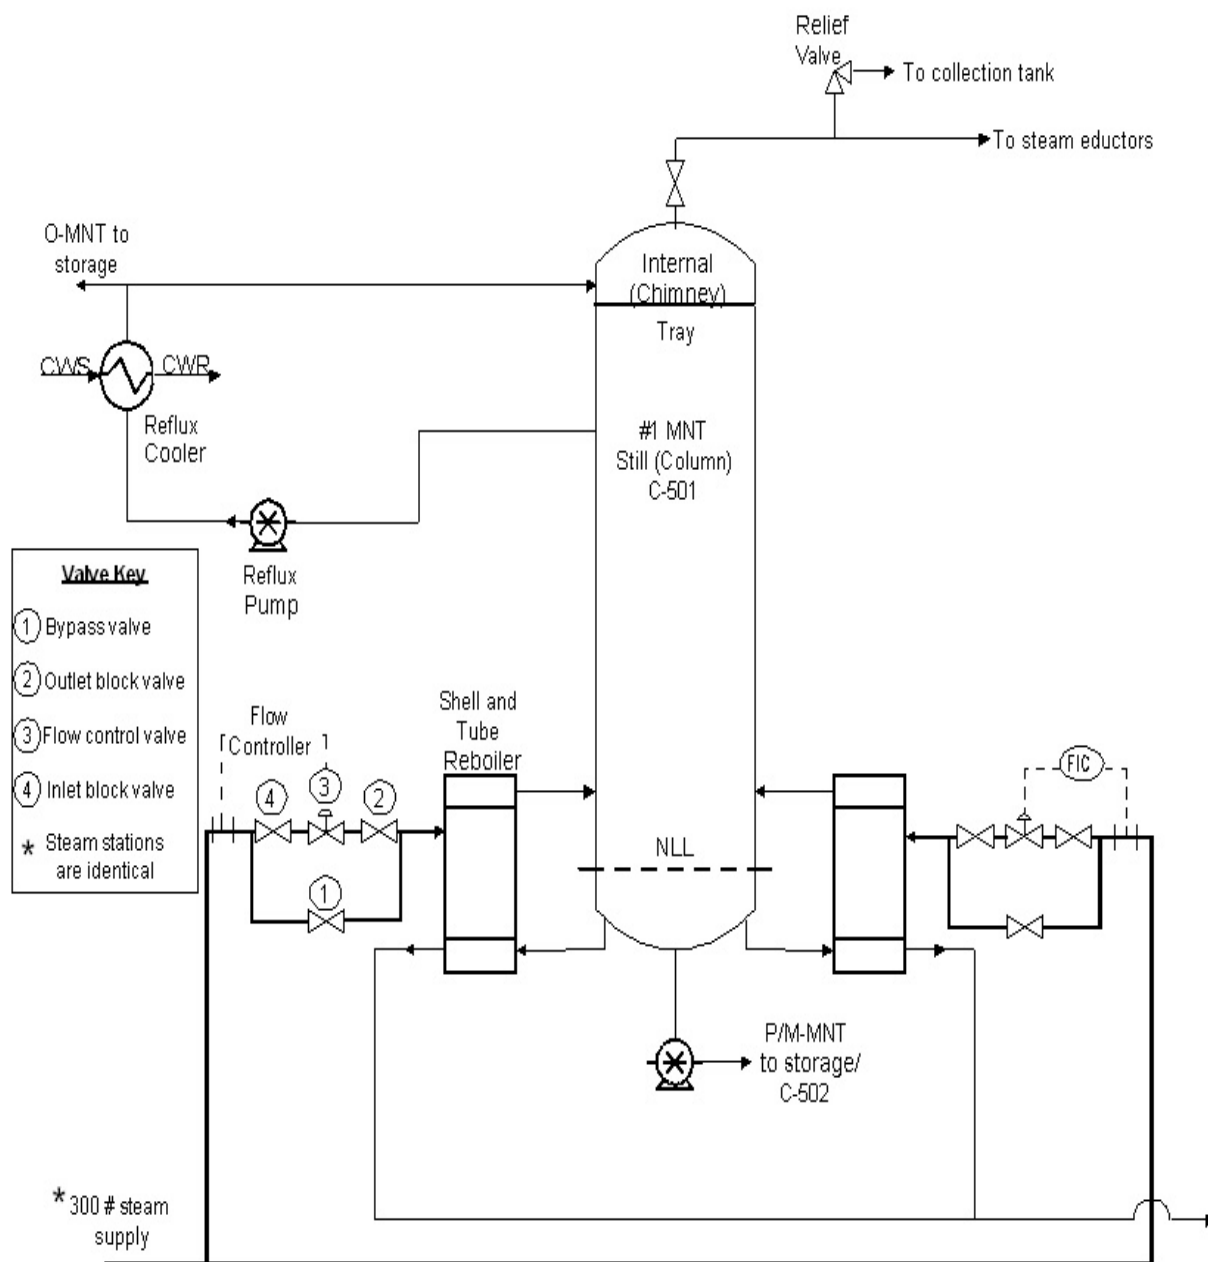
Figure 2. #1 MNT distillation column (C-501) and related equipment.

CSB examined how heat could have been applied to the MNT that remained in C-501 after it was shut down. Separate supply lines carried steam to the two reboilers at the base of the column. Manual valves downstream of the control valves in both lines and both bypass lines were closed on September 22, as confirmed by log entries, interviews, and the as-found position of the valves. In addition, the flow control valves had been commanded closed from DCS. CSB tested both valve stations to determine if they had leaked and the likely cause. Each station consisted of four valves, as shown in Figure 5.

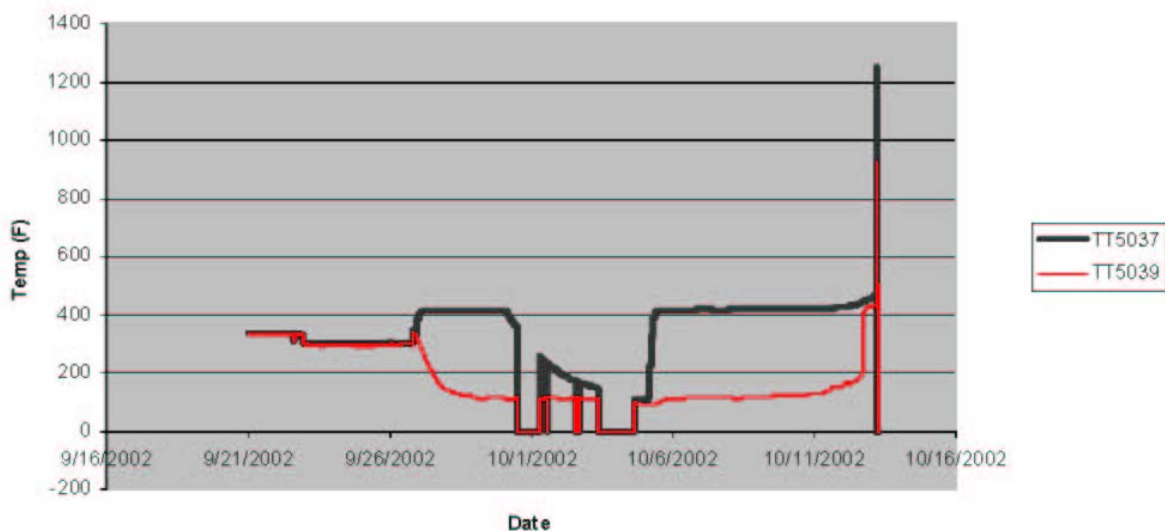
Operations personnel did not actively monitor the temperature. Figure 3 shows a chart of the DCS data for the bottom two temperature indicators.

Maintenance on the boilers was completed on October 5, and the system was brought back online. The temperature of the material in the bottom of the column increased to approximately 415°F by mid-morning.

Figure 3. Temperature at column bottoms, September 21–October 13, 2002.  
(Note: Thermocouple TT-5037 [the top line shown for 10/11/2002] was at the bottom of the vessel, and TT-5039 was above the reboiler inlet line.)

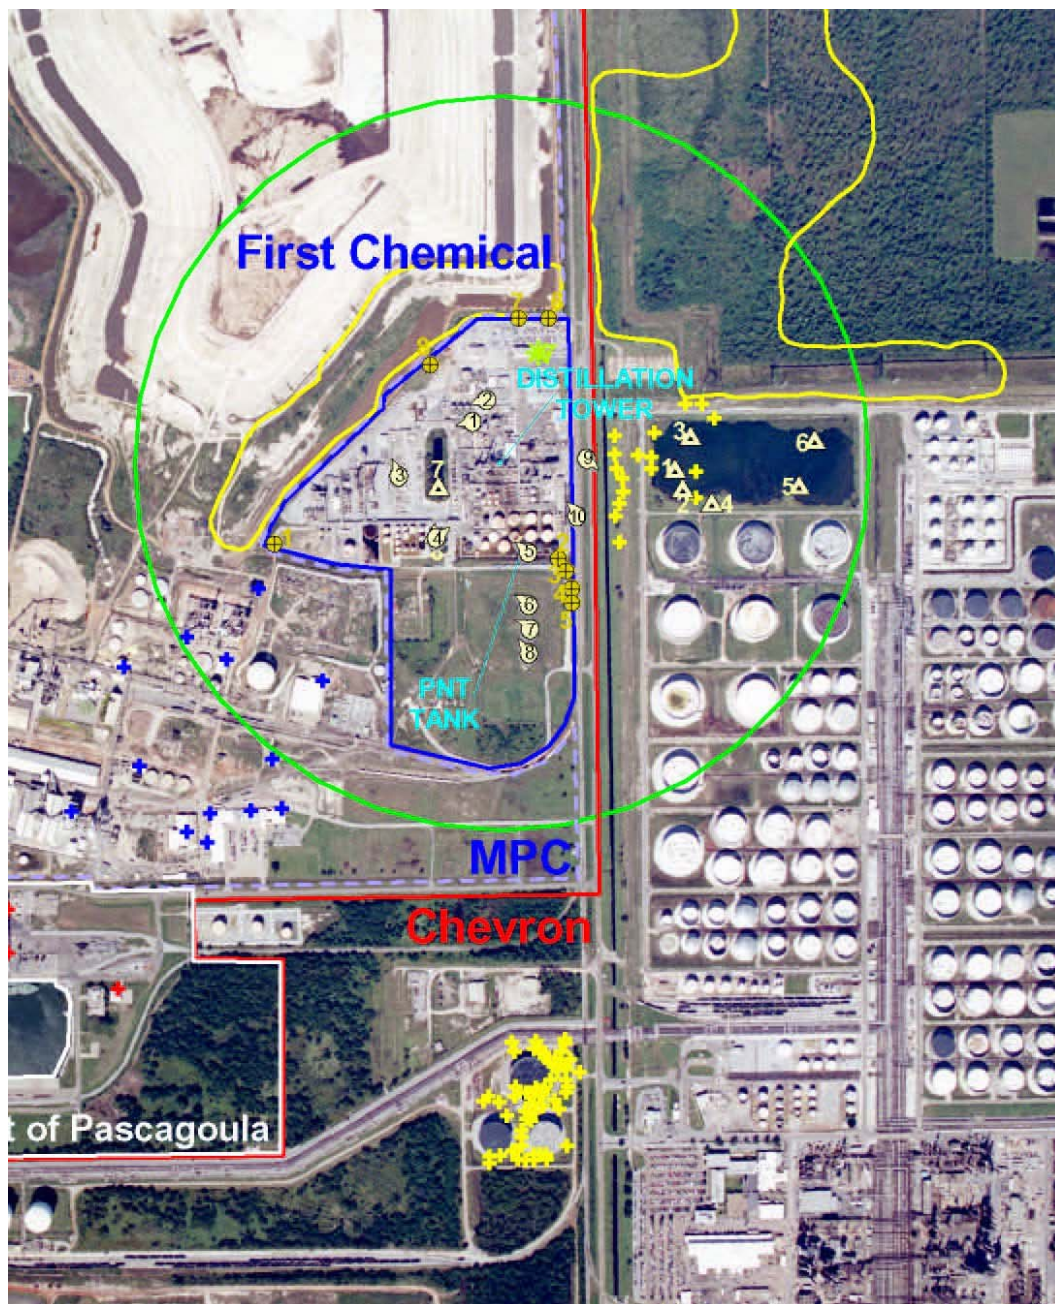
Within this radius of potential impact were several pieces of equipment that contained flammable and toxic material, including tanks and piping. As previously discussed, a crude MNT storage tank at FCC (which contained para-MNT) was hit by shrapnel and caught fire. A number of other potential receptors, including chlorine cylinders and sulfuric acid tanks, were located within the area of debris. If debris had hit this equipment, it is likely that the incident would have caused significant secondary releases of material. (See Figure 4 for an aerial map of FCC and the surrounding area.)

Figure 4. Aerial map of FCC facility showing post-incident debris pattern.  
(Circle shows a 2,000-foot radius from the column, where the search for debris occurred; numbered triangles show the location of various metal debris; crosses denote areas where some of the packing landed outside FCC property.)

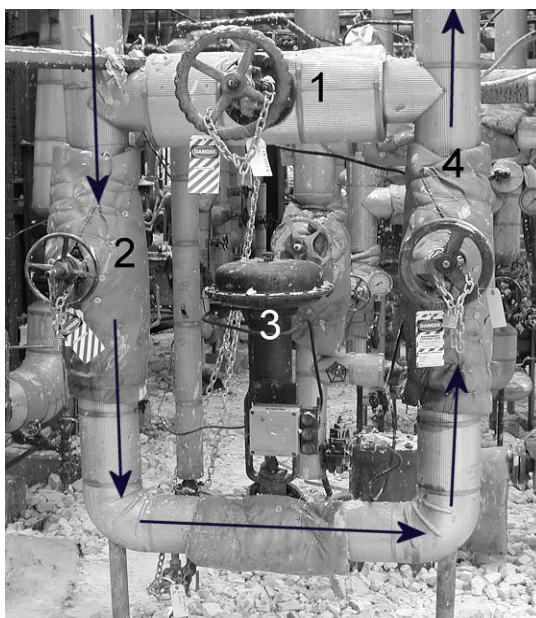
Figure 5. Steam line to reboiler. (The numbered valves represent: (1) manual valve in the bypass line, (2) inlet block valve, (3) automatic flow control valve, and (4) outlet block valve.)

CSB contracted to have the steam stations tested in the as-found condition of the valves to determine leak rate. Data from these tests showed that the manual valve in the bypass line for one of the stations was leaking significantly, over 180 pounds/hour. Corrosion and erosion caused a breach in the valve; the steam flow caused holes to form in the seat of the valve, one of which is shown in Figure 6.

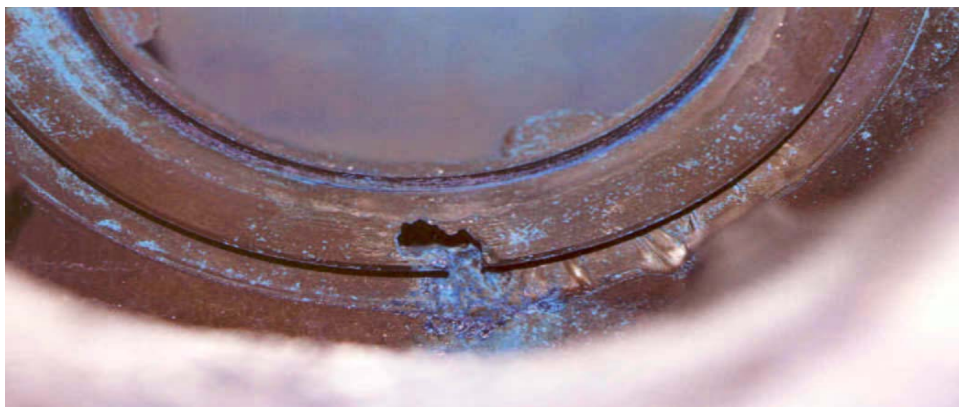
Examination of the other steam station indicated that it leaked as well. Although the manual valve in the bypass line (i.e., valve “1” in Figures 2 and 5) did not appear to leak, the facing on the outlet block valve (the valve downstream of the flow control valve) was severely scored from corrosion products and debris in the system. Because the flow control valve was not intended to be a tight shut-off valve, steam likely leaked through the main branch. Based on examination of the outlet-blocking valve for that station (i.e., valve “2” in Figures 2 and 5), it is believed that debris and particulates may have prevented the valve

Figure 6. Breach in valve seat for bypass valve.

from seating properly. The steam system was “moist”—meaning that it contained liquid as well as steam vapor, which contributed to additional erosion and corrosion of the piping system.

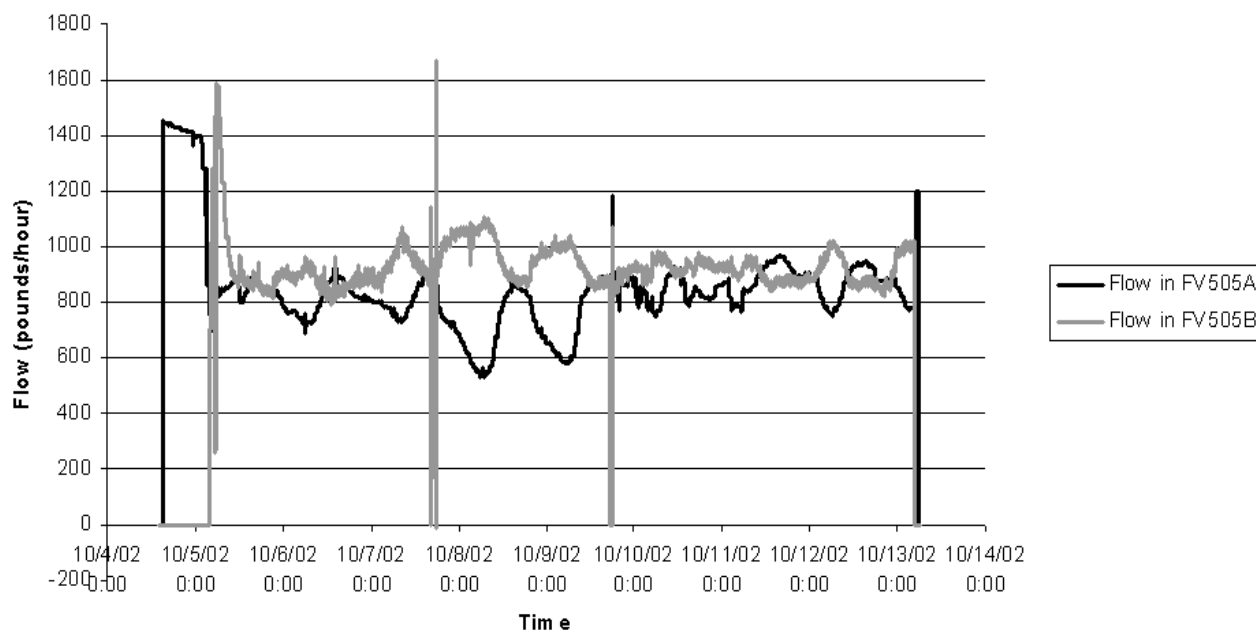
These results verify that steam likely leaked through manual valves and continued to heat material in C-501, even though the valves were in the closed position. These findings are consistent with DCS data, which indicate that there was flow through the line when the valves were closed and believed to be isolating the steam source from the MNT column (Figure 7). DCS data, though exhibiting an erratic pattern, indicate even higher flow rates than were found during CSB testing. Although the registered flow rates indicated in the DCS data may not be correct, they illustrate that flow was occurring in the system at a time when the column was believed to be isolated.

Figure 7. DCS readout of steam flow to reboiler when system was believed to be isolated.

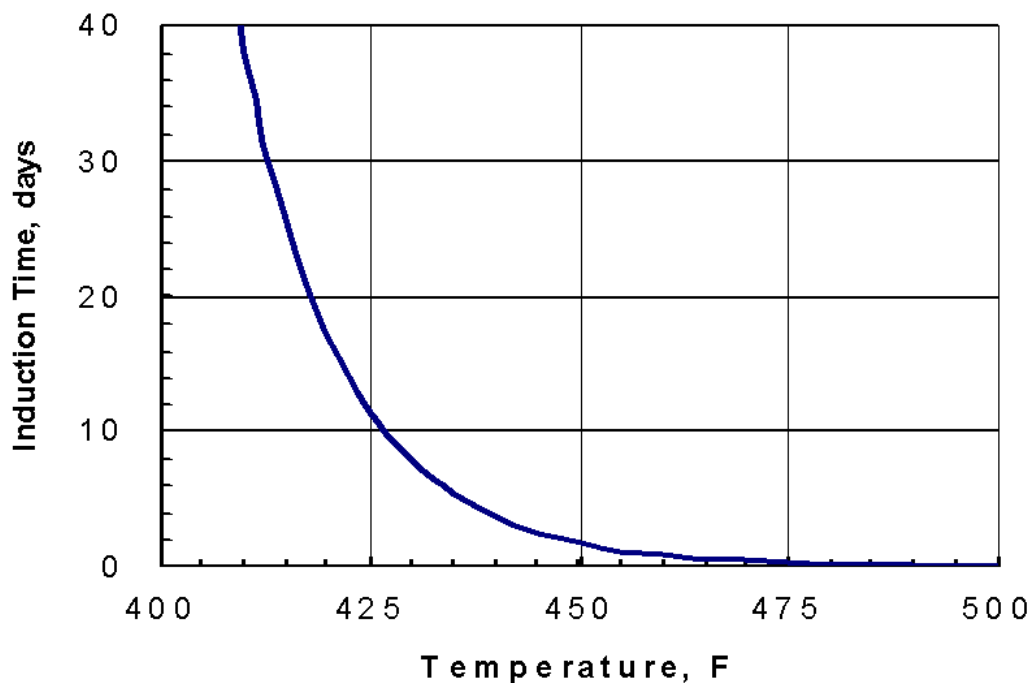
Figure 8. Mononitrotoluene induction time-temperature data on linear scales.

These results are consistent with information found in literature concerning the decomposition of MNT. In a paper presented at an Institution of Chemical Engineers (IChemE) symposium, the authors note that a number of incidents occurred when MNT was heated to excessively high temperatures or held at more moderate temperatures for an extended time (Harris, Harrison, and MacDermott, 1981). The latter phenomenon is referred to as the “induction effect.” For large batches of material (on the order of the amount in C-501 prior to the incident) that are exposed to temperatures between 401° and 419°F, a violent decomposition will occur within 8 to 25 days. This is consistent with conditions at FCC prior to the incident.

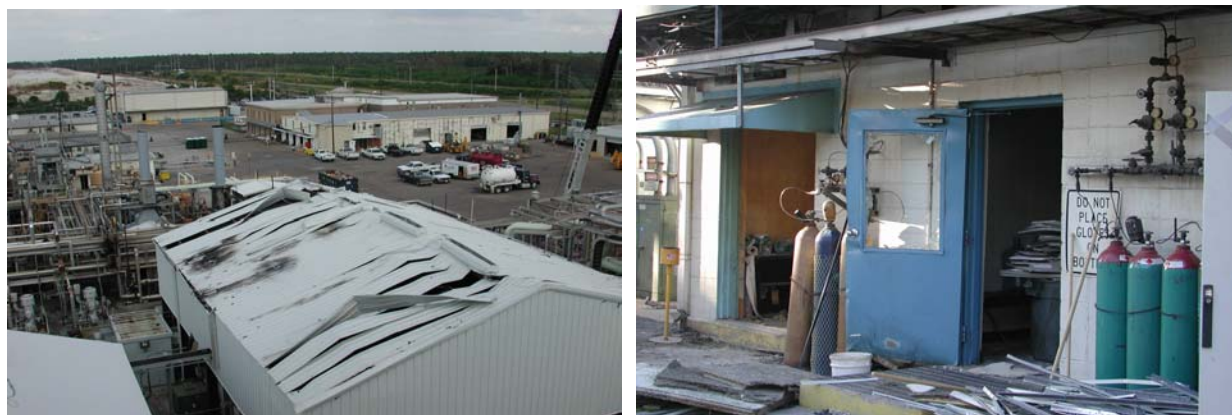
The pressure of the explosion damaged a number of buildings onsite, including the control room. Almost all of the acoustical drop ceilings in the control room and adjacent laboratories and breakrooms collapsed. The roof was extensively damaged, cinderblock walls were cracked and distorted, and the exterior doors were buckled and glass broken. An administration building—located over 400 feet from C-501—was also significantly damaged, including impact from a piece of shrapnel that punctured the cinderblock wall adjacent to an office. A number of additional steel-frame construction buildings sustained damage to roll-up doors and corrugated siding on the side facing the failed column.

(Figure 9). Several other buildings onsite were damaged, including the administration building, which was located approximately 450 feet from C-501.

Figure 9. Damage to control room roof and door.
